**VI. Design Guidelines Part III:  
Specific Elements**

## DESIGN GUIDELINES PART III: SPECIFIC ELEMENTS

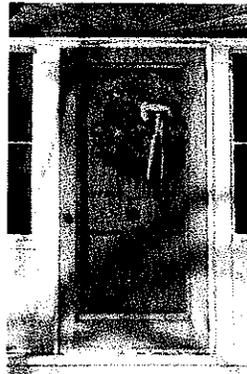
This is an appropriate storm door installation because the storm obscures only a small part of the entry door.

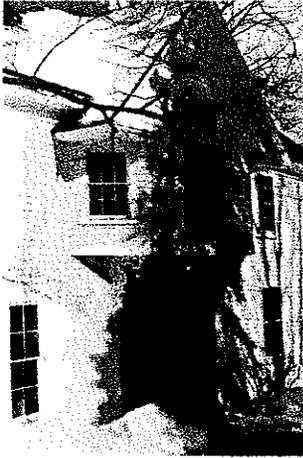
This attached carriage barn is an excellent example of the level of architectural detail that can be found on an outbuilding. Note the use of brackets as a "support" of the bay and the elliptical window.

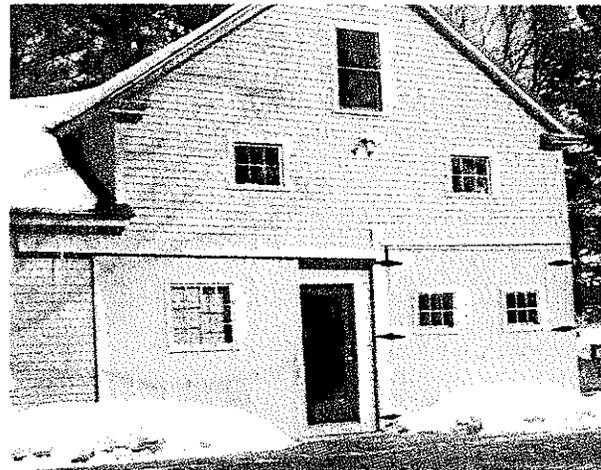
This is an excellent example of introducing a new opening and yet maintaining the historic context. The integrity of the historic sliding barn door is maintained even though a new opening has been added.

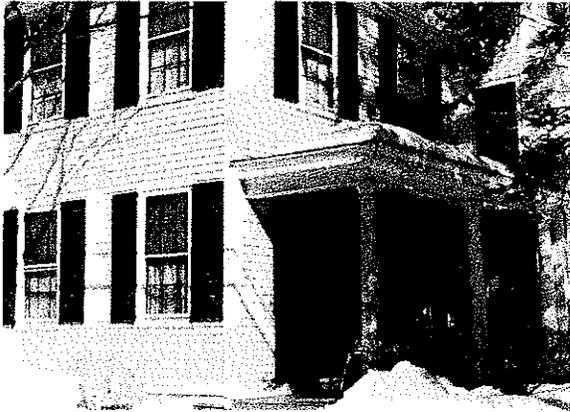
Attached side porches like this one are found on several houses in the historic districts.

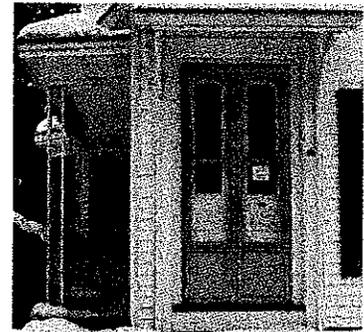
Here the side porch columns have been replaced with modern metal supports. This change in material and form is not a compatible replacement.

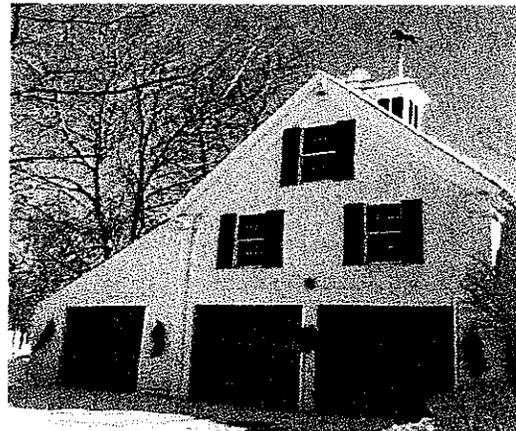
The carriage barn has an end gable roof adorned with a cupola that has a weathervane. Also, note that a shed roof marks a later addition on the left side of the building. All of these elements are important character defining features.

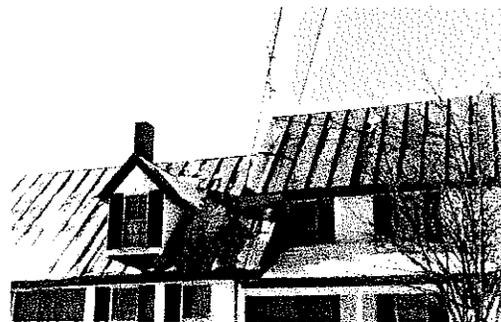
Metal roofs are common on many houses in the historic districts.

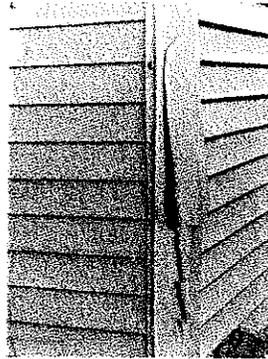
Vinyl or aluminum siding can be damaged. The damage shown in the picture to the left allows moisture into the building thus creating more building problems which will not be immediately visible until extensive damage has been done.

The application of aluminum or vinyl siding over clapboards can also trap and conceal moisture and insect problems, which may result in extensive damage to a structure. In addition siding can be dented and cracked, which once damaged it loses any semblance to the material it was attempting to simulate. Therefore, aluminum or vinyl siding is not appropriate in the historic district.

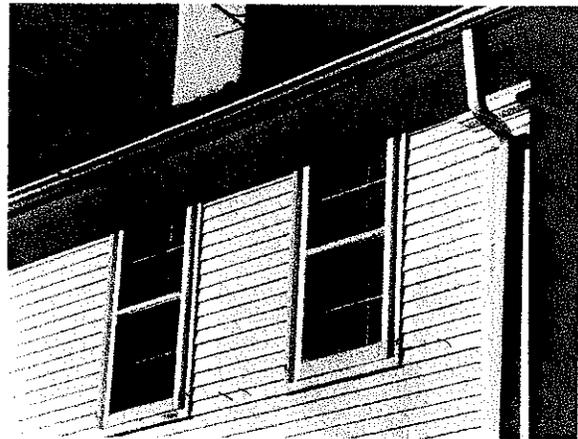
Wood clapboards are the typical exterior wall treatment in Topsham.

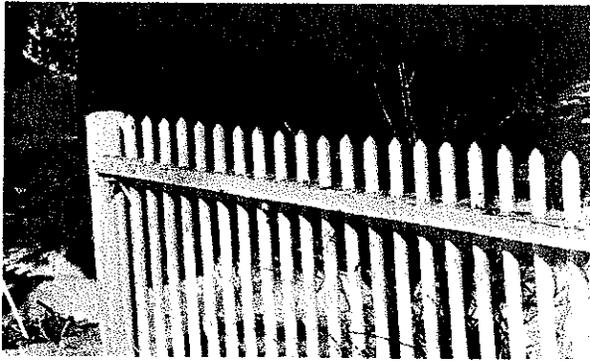
Wooden fences are an important site defining feature.

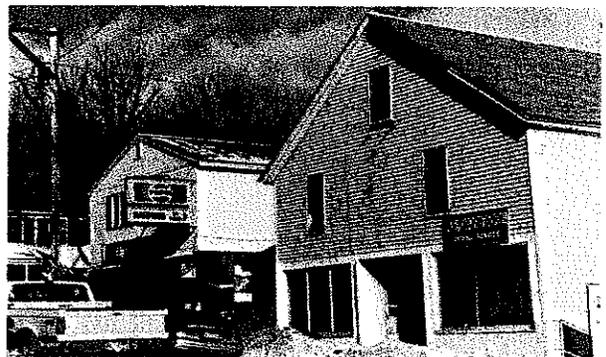
Storefronts such as these along lower Main Street have been greatly altered through the years. In some cases, historic details may survive beneath the aluminum or vinyl siding.

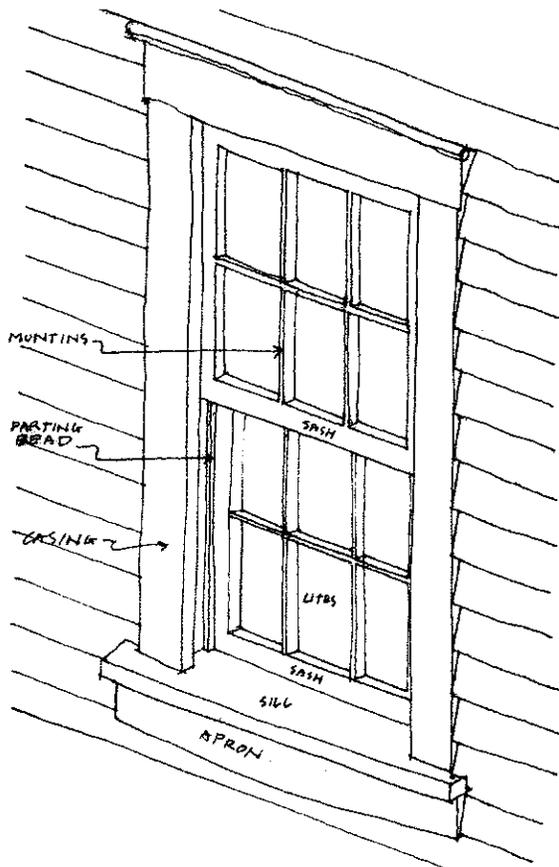
The parts of a window.

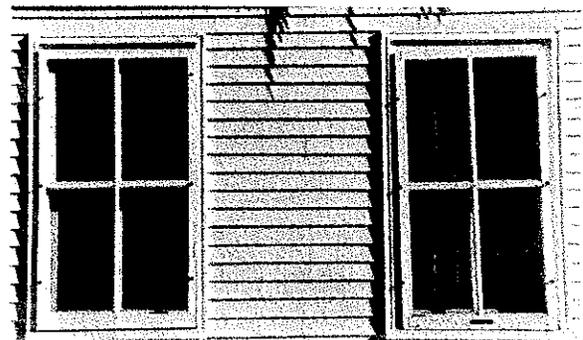
Maintaining or replicating the original exterior wooden storms is an appropriate design solution for older windows. The storms should match the configuration of the windows.

Another consideration for air infiltration is the use of storm windows. Storm windows may be used on the exterior or the interior of a property. Although they may compromise the visual appearance of a building's exterior, storm windows are not permanent and may be removed in the future without permanently altering the historic building. Storm windows can also be painted the same color as your sash (originally often flat black) and almost disappear in their unsightliness.

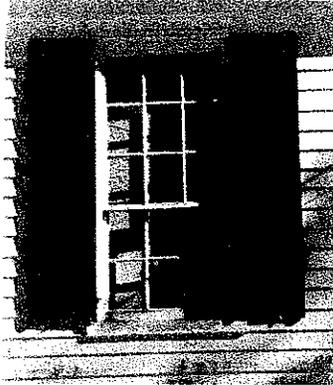
Wood double-hung windows are typical of houses throughout the district.
